Manhole Inspection Summary

Manhole # S49CC_044MH

Record Plat: **49CC** Node: **044** Status: **Found**

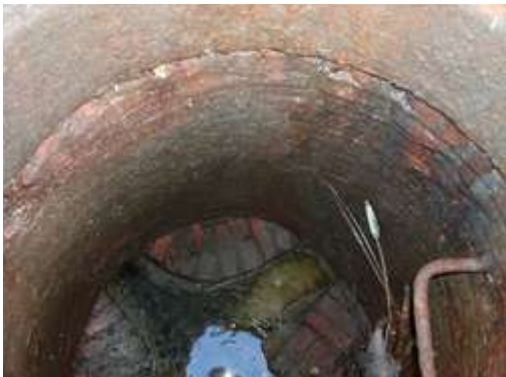
Defect 1

Chimney / Frame Adjustment ☒ Exists Material: **Brick** ☐ Parged Height: **6** (in.)

Infiltration: ☐ None ☒ **Joint** ☐ Cracks ☐ Mortar ☐ Roots ☐ Wall

adjustment joint

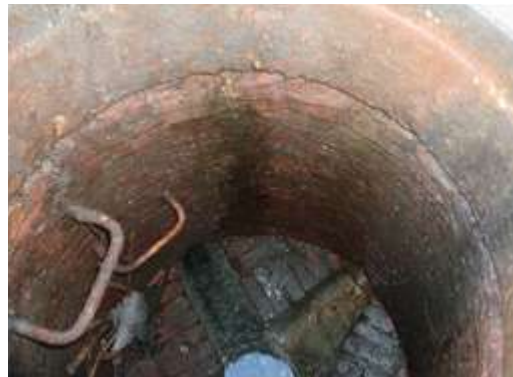
Defect 2

Frame Offset: **0** (in.) Condition: ☐ Sound ☐ Cracked ☒ **Leaks**

frame leaks

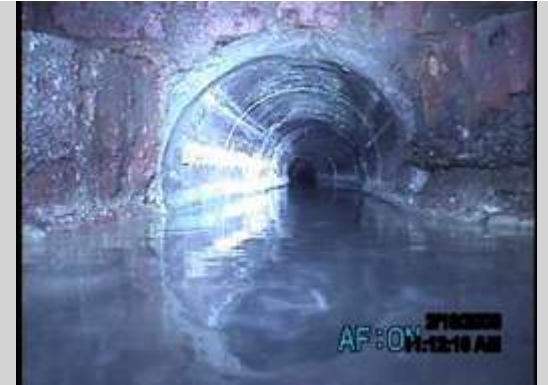
12 O'Clock Outflow

8 in. Circular Gravity Sewer
Pipe Out @ 12 O'Clock

Pipe Height: **8.4** (in.) Rod and Bar (Angled)
Pipe Material: **Clay** ☐ Pipe Lined
Invert Depth: **7.30** (ft.) Flow Characteristics: **Slow**
Deposits: ☐ None ☐ Mud ☐ Sludge ☒ **Debris** ☐ Grease
Silt Depth: **1** (in.) Deposits Extent: **Light**
Infiltration: **None** Pipe Seal Cond: **Sound**

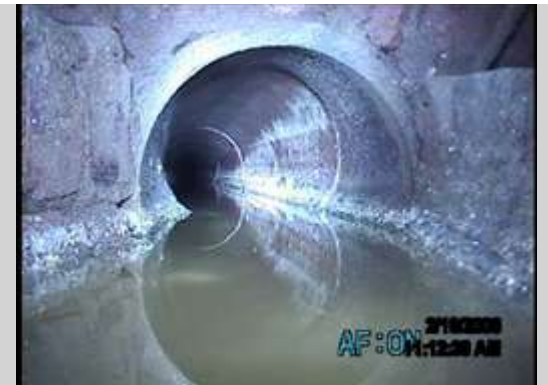
3 O'Clock Inflow

8 in. Circular Gravity Sewer
Pipe In @ 3 O'Clock

Pipe Height: **8.4** (in.) Rod and Bar (Angled)
Pipe Material: **Clay** ☐ Pipe Lined
Invert Depth: **7.30** (ft.) Flow Characteristics: **None**
Deposits: ☐ None ☐ Mud ☐ Sludge ☒ **Debris** ☐ Grease
Silt Depth: **4** (in.) Deposits Extent: **Heavy**
Infiltration: **None** Pipe Seal Cond: **Sound**

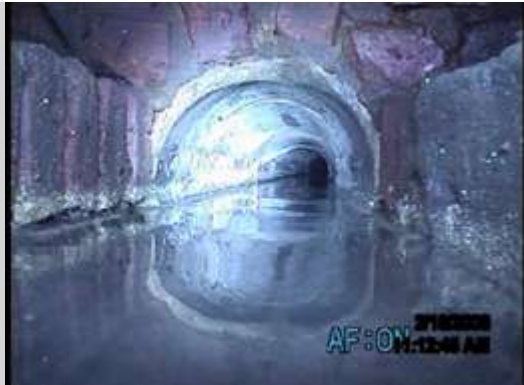
6 O'Clock Inflow

Deposits: ☐ None ☐ Mud ☐ Sludge ☒ Debris ☐ Grease

Silt Depth: **1** (in.) Deposits Extent: **Light**

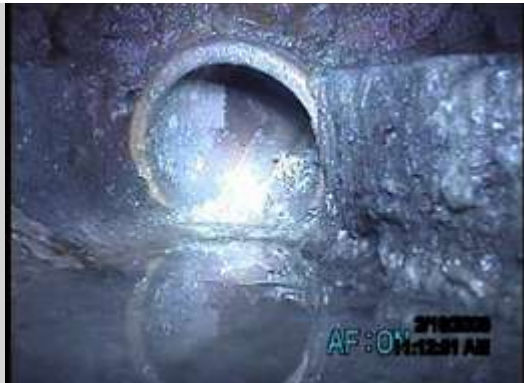
9 O'Clock Inflow

Deposits: ☐ None ☒ Mud ☒ Sludge ☒ Debris ☐ Grease

Silt Depth: **5** (in.) Deposits Extent: **Heavy**
